National Transportation Safety Board

Safety Recommendation

Date: January 15, 1998

In reply refer to: A-98-1 and -2

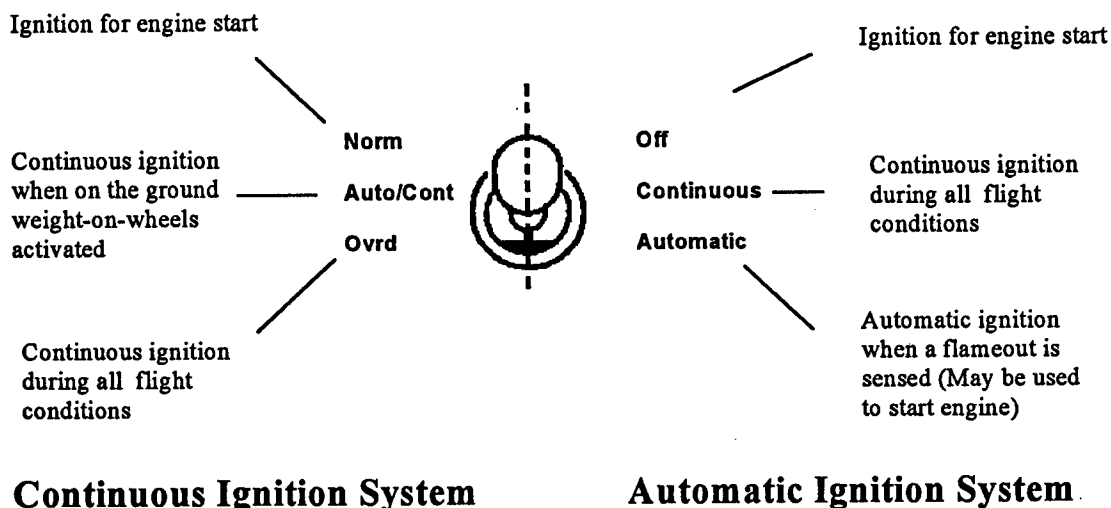
Figure 1. Typical Ignition Switch Position Labeling in TPE331-powered Airplanes

not truly automatic because the pilot must first select an ignition mode using a manually selectable three-position switch. Flameouts can be detected by the decay in certain engine parameters, such as engine revolutions per minute or torque. The automatic ignition system can relight the engine without pilot action or awareness of any engine or airplane performance changes if the ignition mode switch is in the automatic position.
